Ecological Approach Used to Remediate Former Mining Site

Cleanup of the inactive Burlington Mine site in Boulder County, CO, was initiated in 2003 as a voluntary cleanup overseen by the Colorado Department of Public Health and Environment (CDPHE) pursuant to the Colorado Voluntary Cleanup Redevelopment Act of 1994. An ecological approach was used to improve downstream water quality, reduce surface- and ground-water interaction with contaminated materials, and limit potential for subsidence. Activities included the filling and mounding of subsidence pits, realignment of intermittent tributaries, management of surface-water runoff, and revegetation of barren areas.

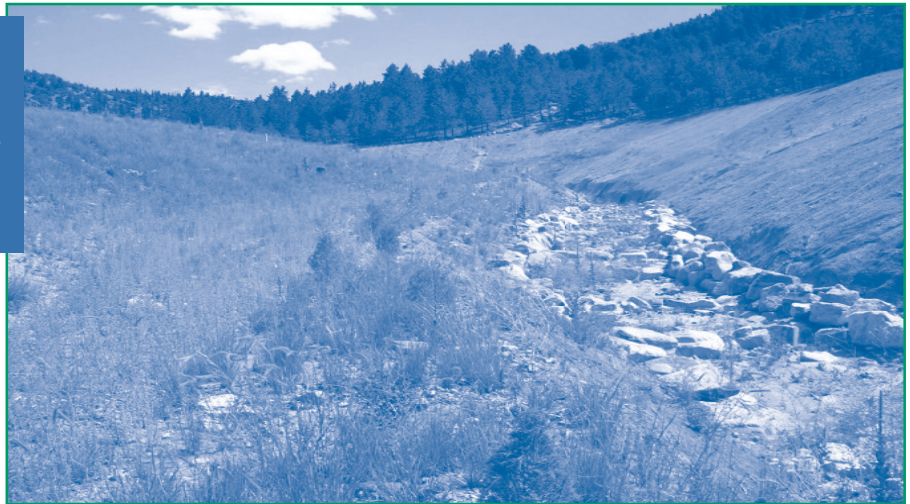
Figure 2. The ecological approach used to address AMD in the Balarat Gulch relies on revegetation with native plants to help stabilize banks of the diversion channel constructed four years ago.

prevent waterfowl from landing or residing in a pond receiving constant discharge from underlying mine tunnel. After three growing seasons, vegetative coverage is as low as 5% (in sections of the steep 2:1 hillslope), but as high as 85% in other areas (Figure 2). Complete revegetation is expected to require 10-20 years. CDPHE estimates a total cleanup project cost of \$1.5 million, or about \$140,000 per acre.
